Blog 46: Looking Up

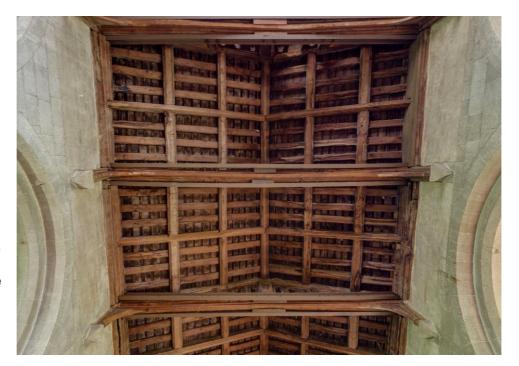
It was 1978 and I had been through the whole checklist; gutters, roof, tower, bells and around 180 other items, making notes for my report. I was about to leave St Andrews Church, Shrivenham in Wiltshire, UK when I looked directly upwards, leaning backwards. One of the main oak roof truss tie beams which supports the nave roof was curved, not straight as it should be.

It had been there undisturbed since 1638 but now we had trouble. Closer inspection from scaffolding showed that urgent repairs were needed before the main structure, which was suffering from timber decay, gave way. It was not possible to replace the beam without dismantling the roof so the next best option was two steel beams on either side, bolted together through the timber.

St Andrew's Shrivenham, strengthened roof structure. Photo by Nikhilesh Haval
